Technical Report REMR-CS-60
September 1998

Repair, Evaluation, Maintenance, and Rehabilitation Research Program

Performance Criteria for Concrete Repair Materials, Phase II Field Studies

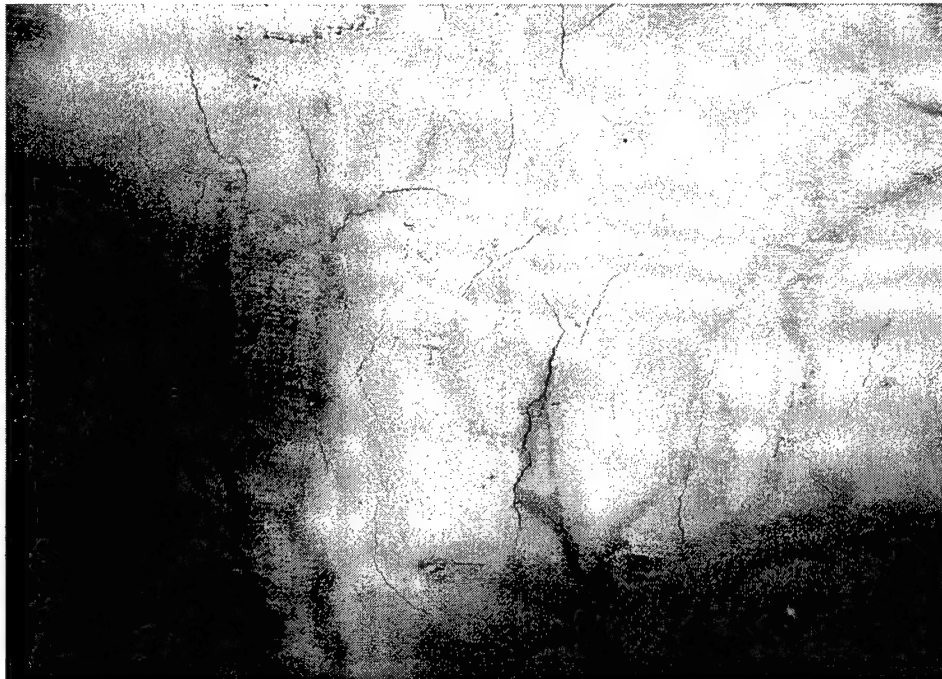
Figure 12. Severe cracking, Material No. 5 (Florida)

recommendations, the mixture was not extended with aggregate in the Florida tests. Despite immediate sprinkling with water after finishing, early age, plastic-shrinkage cracking occurred in each of the three repairs (Figure 12).

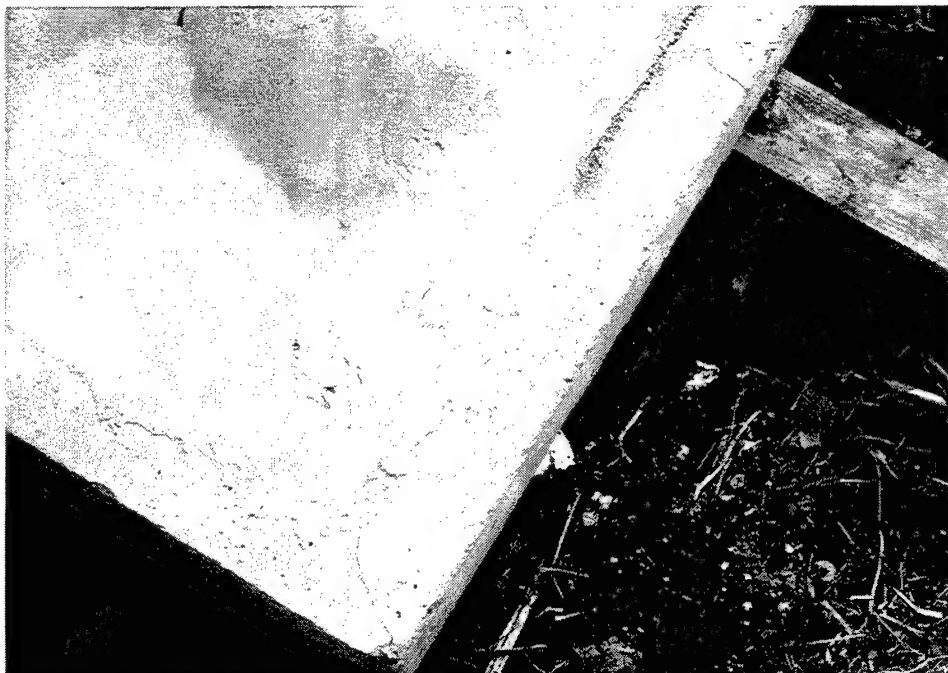
Figure 13. Cracks in the cavity walls, Material No. 5 (Florida)

The rapid setting of Material No. 5 was accompanied by a high heat of hydration. Expansion of the repair material associated with the high temperature rise was sufficient to cause cracking in the precast concrete cavity walls (Figure 13). Subsequent cooling and restrained contraction of the repair material may have contributed to the early age cracking observed. Consequently, the manufacturer recommended that the mixture be extended with coarse aggregate for the remaining tests. Early age cracking in Repair 6C was also attributed to plastic shrinkage.

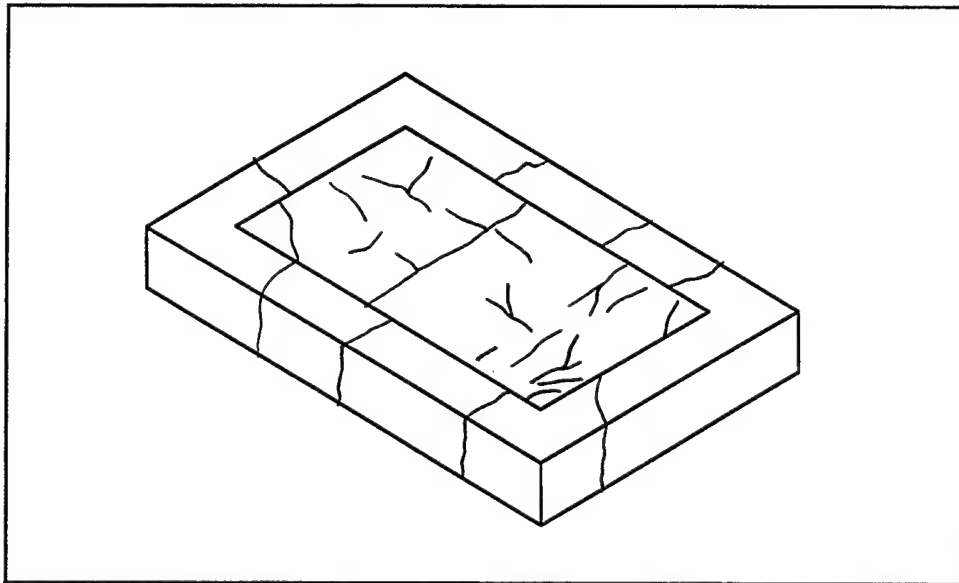
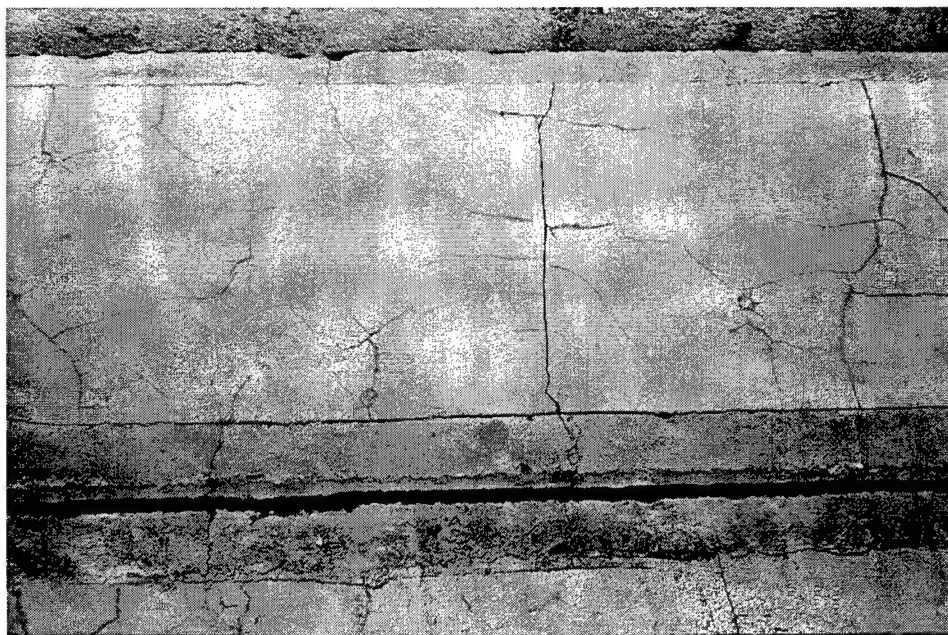
Figure 29. Cracking of Material No. 5A (Florida)

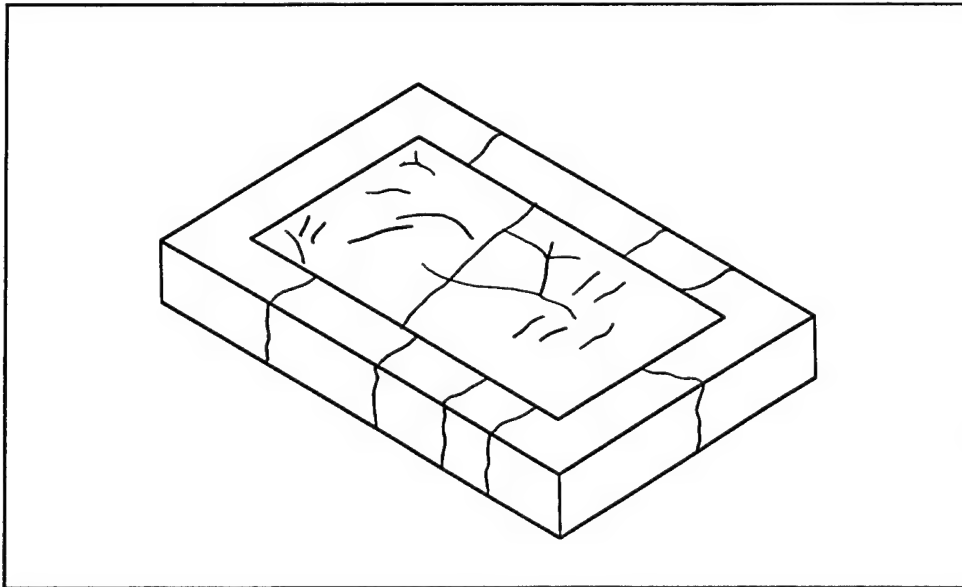
Figure 30. Cracking of Material No. 5B (Florida)

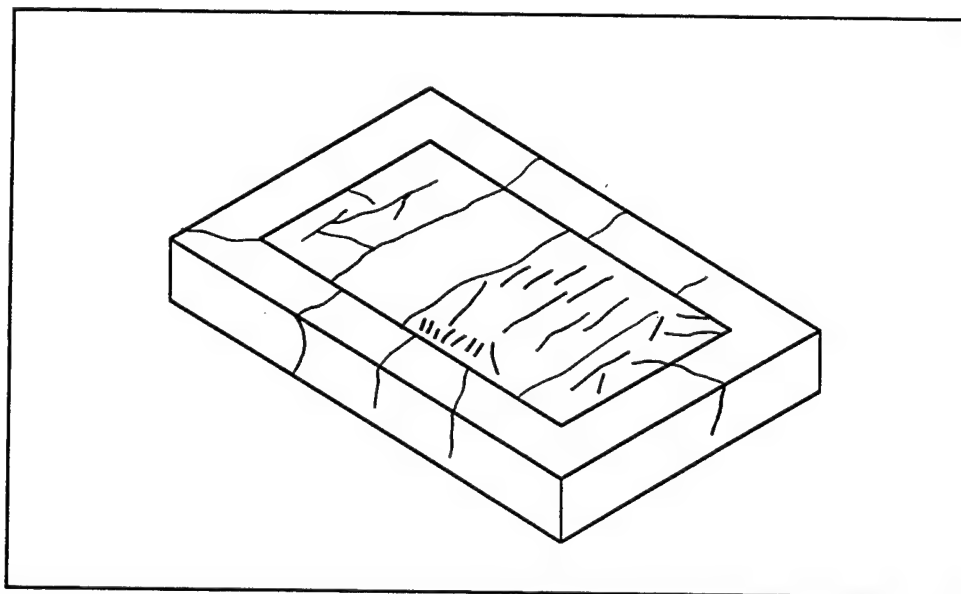
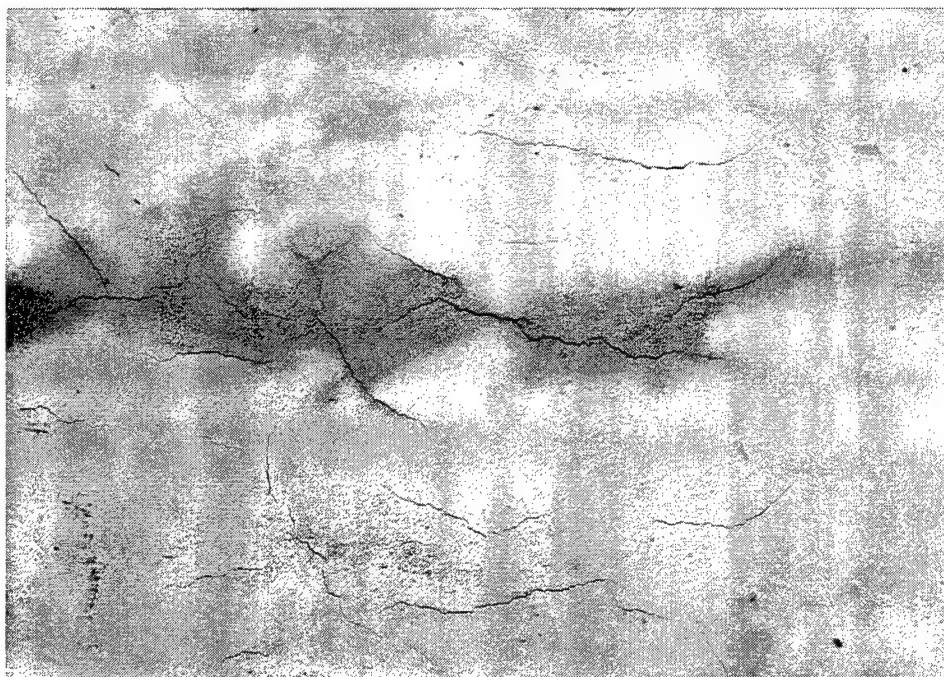
Figure 31. Cracking of Material No. 5C (Florida)

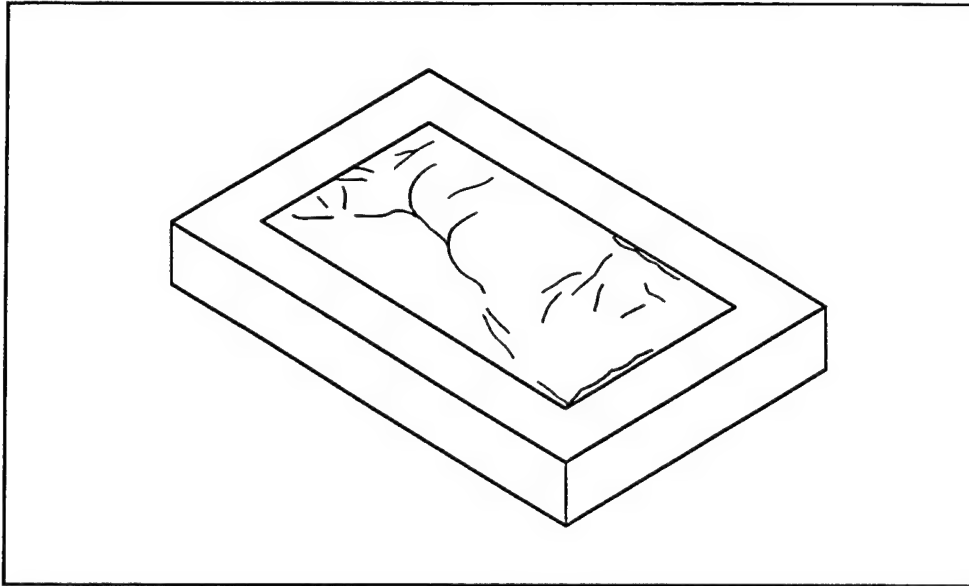
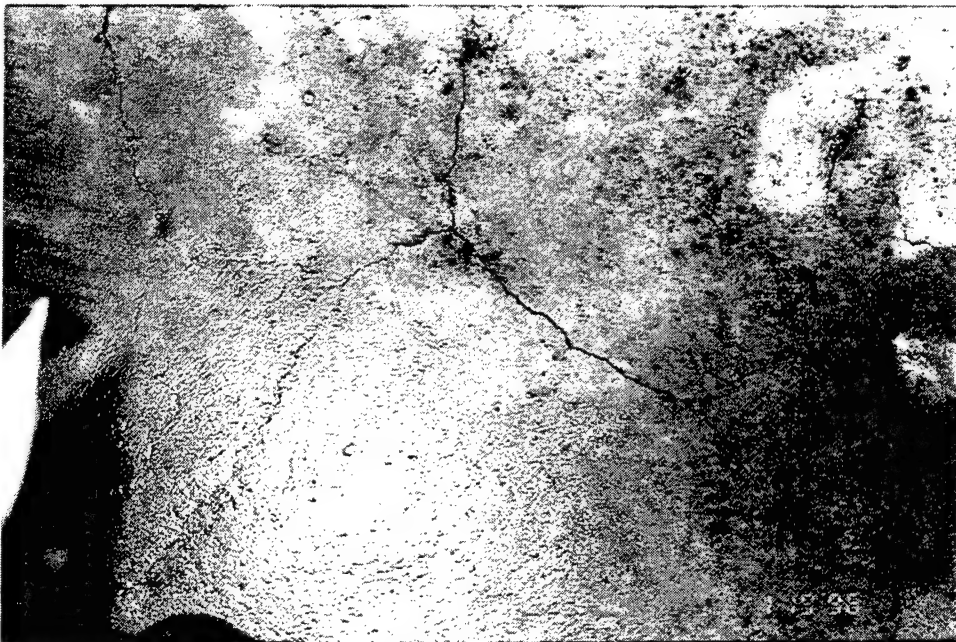
Figure 32. Cracking of Material No. 6C (Florida)

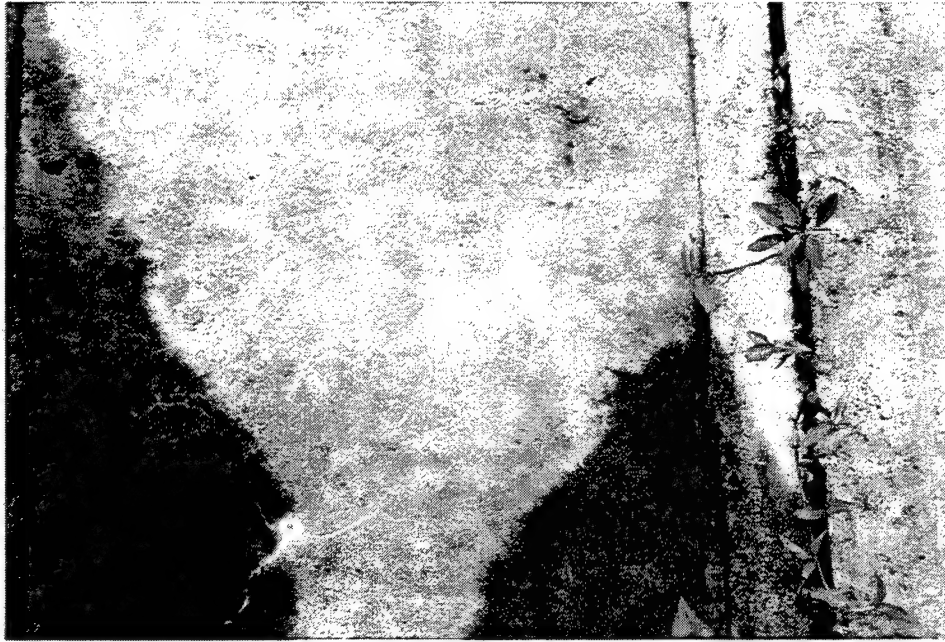
8	08/01/94	Fine surface crazing.	Fine surface crazing.	Fine surface crazing. Figure 33.
9	08/19/94	Minor surface crazing.	No cracks.	No cracks.
10	08/03/94	Very fine surface crazing in repair and cracking in precast form noted at 260 days.	Very fine surface crazing in repair and cracking in precast form noted at 260 days.	Very fine surface crazing in repair and cracking in precast form noted at 260 days.
11	08/04/94	No cracks.	No cracks.	No cracks.
12	08/05/94	No cracks.	No cracks.	No cracks.

Figure 33. Surface crazing of Material No. 8 (Florida)

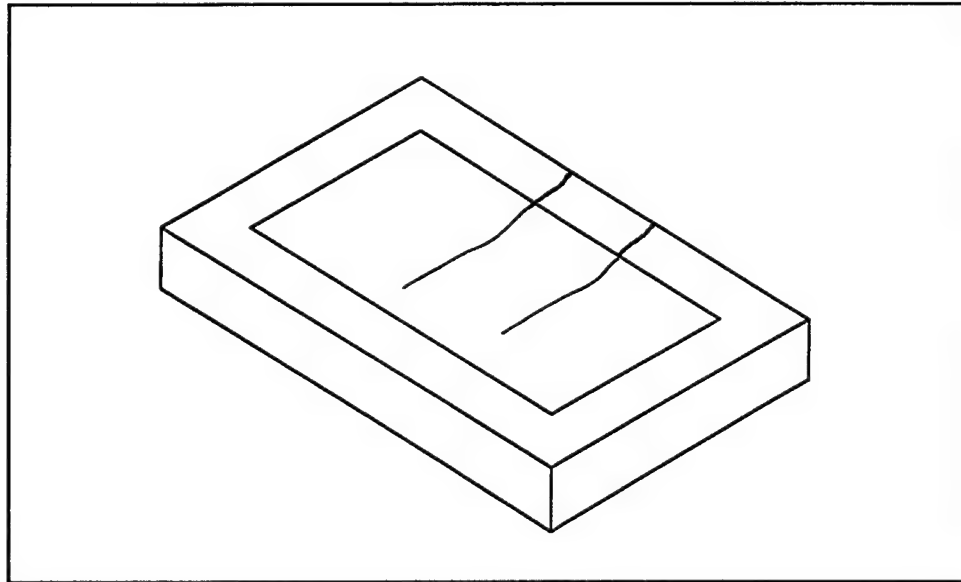
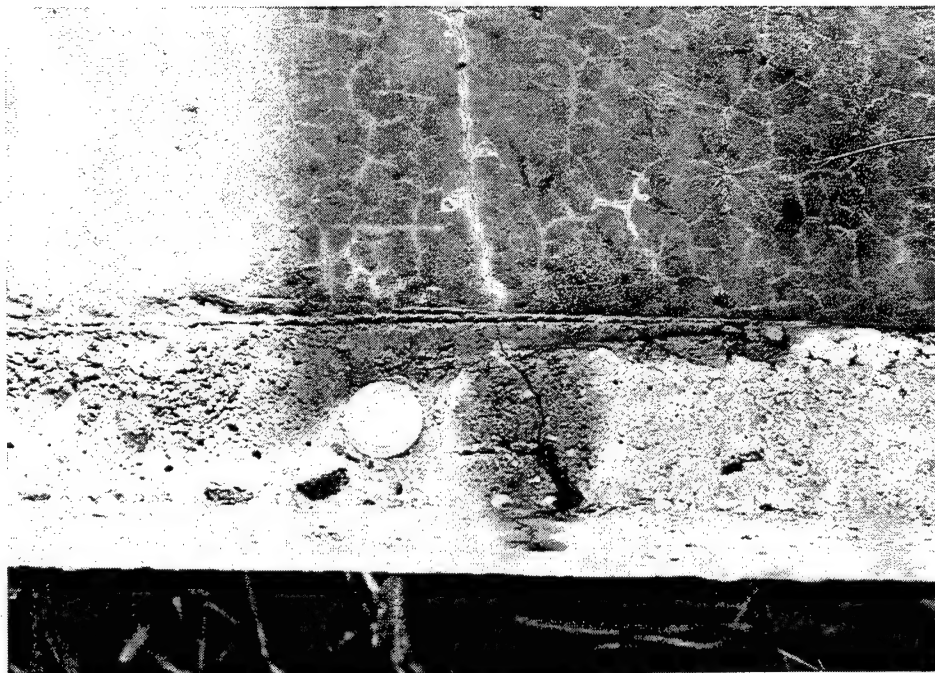
Figure 34. Cracking of Material No. 5C (Illinois)

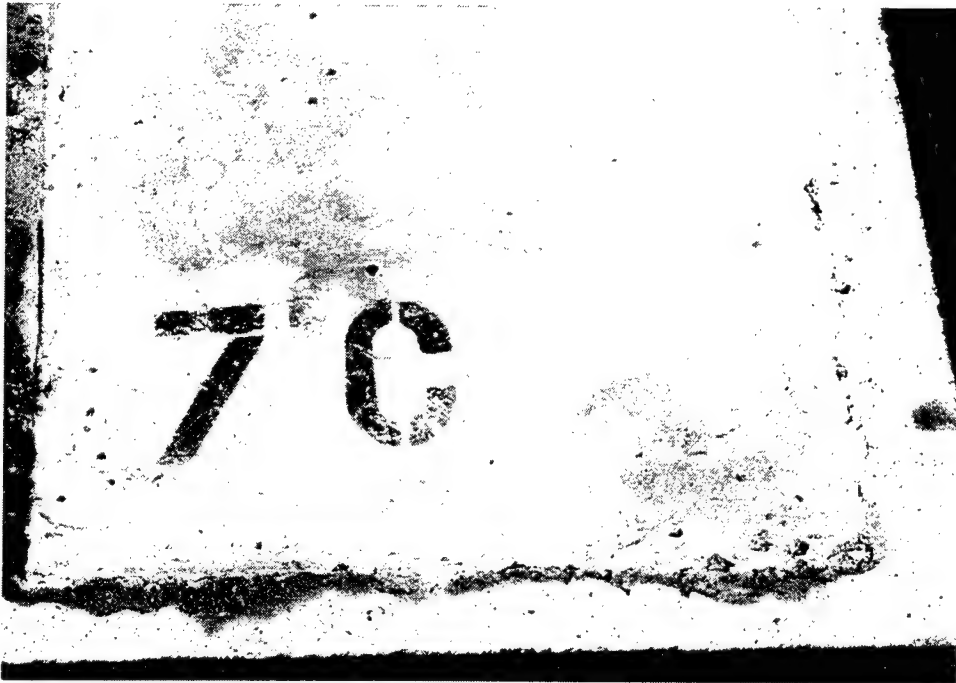
Figure 35. Surface crazing of Material No. 7C (Illinois)

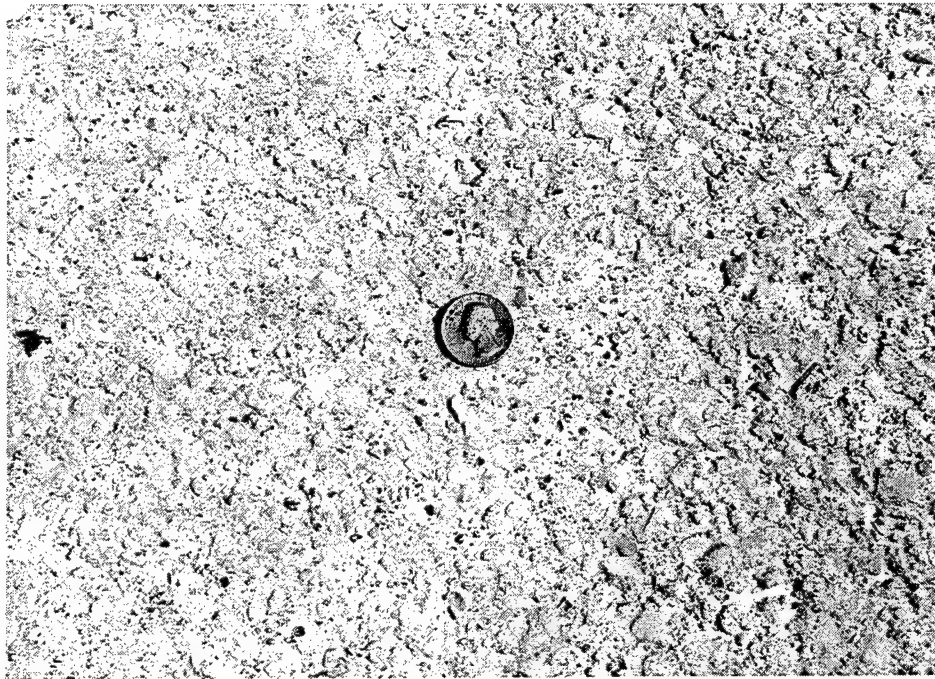
Figure 37. Surface deterioration of Material No. 12C (Illinois)

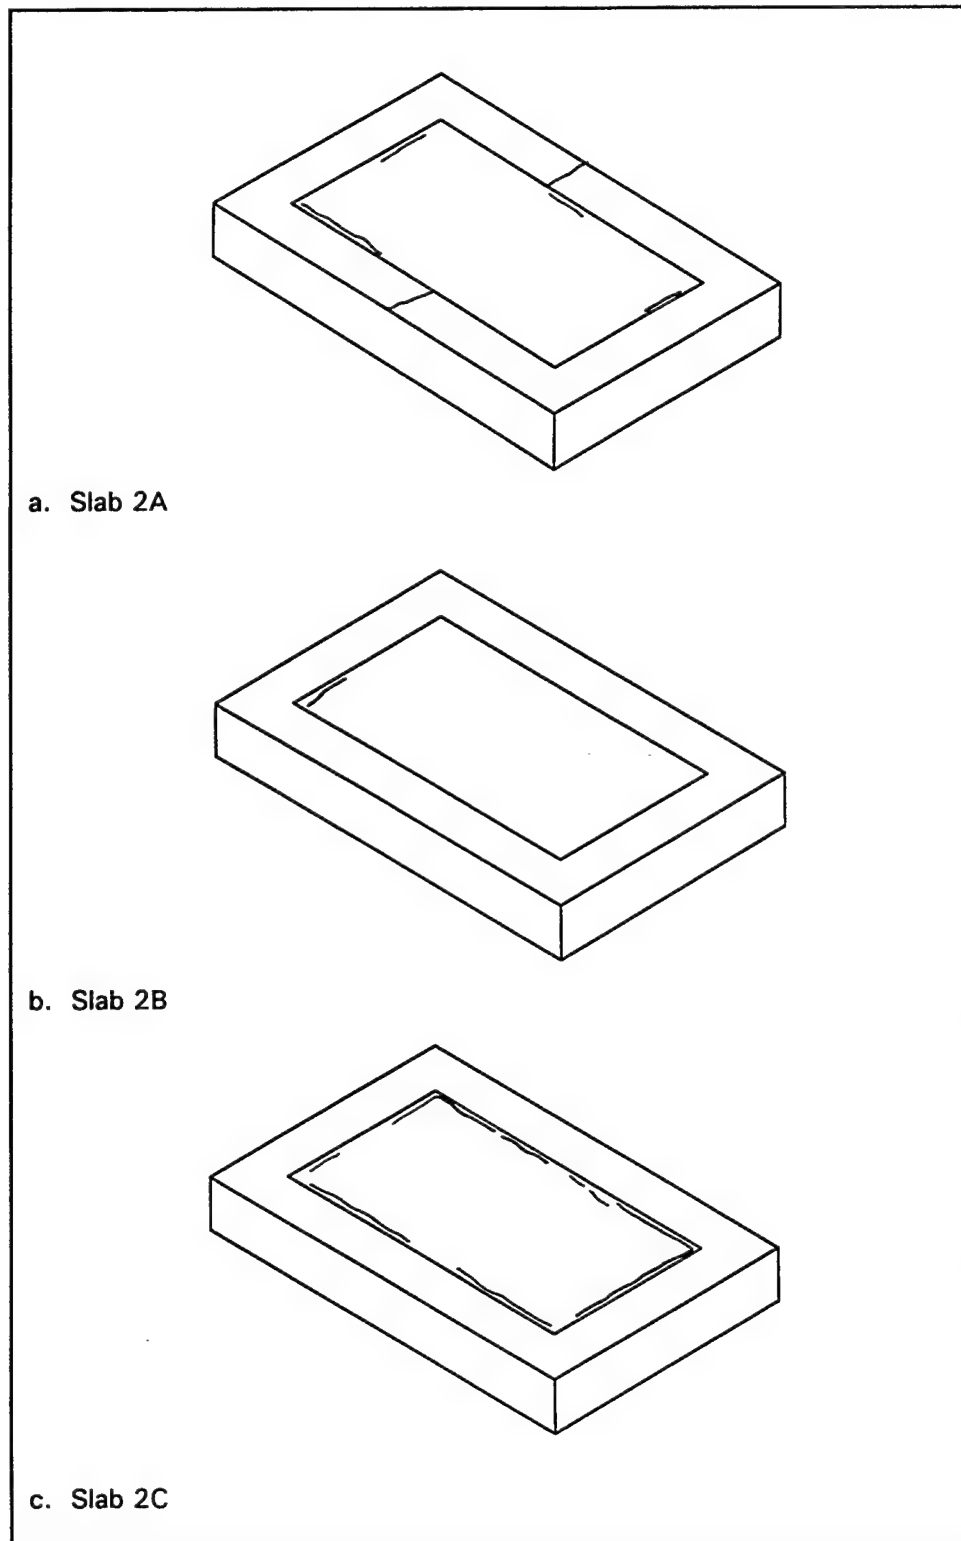
Material No.	Date of Placement	Observations		
		Repair A	Repair B	Repair C
1	12/06/94	No cracks.	No cracks.	No cracks.
2	12/07/94	Four edge cracks noted at 7 days. Figure 38.	One edge crack noted at 7 days.	Seven edge cracks noted at 7 days. Two additional cracks noted at 14 days. One additional crack noted at 28 days.
3	12/06/94	Surface checking noted at 200 days.	One transverse crack noted at 170 days. Figure 39.	Surface checking noted at 200 days.
4	12/07/94	No cracks.	No cracks.	No cracks.
5	12/08/94	No cracks.	One edge crack noted at 7 days. One transverse crack noted at 500 days. Figure 40.	One edge crack noted at 7 days.
6	12/06/94	One edge crack noted at 7 days. One transverse crack noted at 620 days. Figure 41a.	Six edge cracks noted at 7 days. Figure 41b.	Four edge cracks noted at 7 days. Figure 41c.
7	12/06/94	Not cast.	Surface checking noted at 7 days. Three short transverse cracks noted at 135 days. Figure 42.	Surface checking noted at 7 days age. One crack noted at 7 days. Ten additional cracks noted 135 days. Figure 42.

Figure 38. Edge cracking associated with Material No. 2 (Arizona)

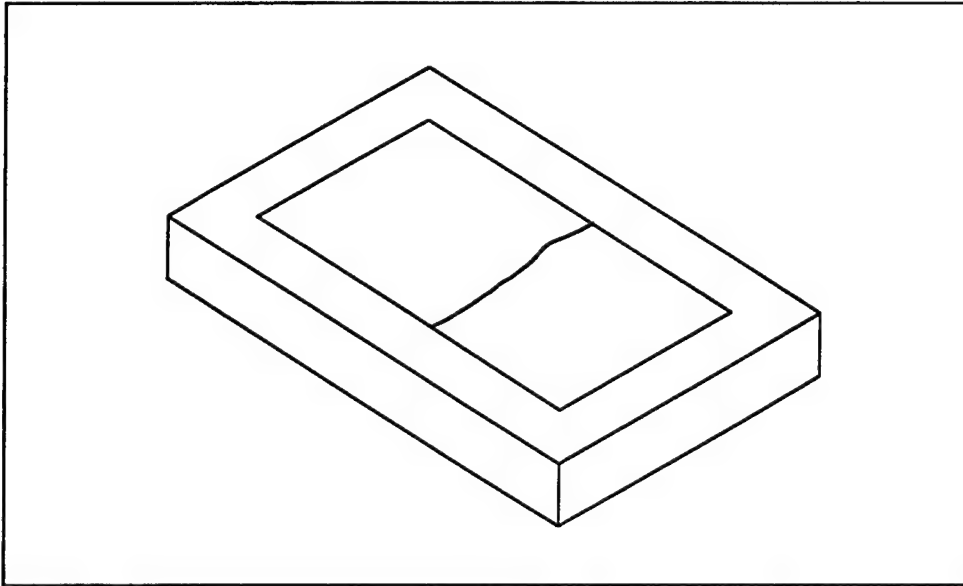
Figure 39. Cracking of Material No. 3B (Arizona)

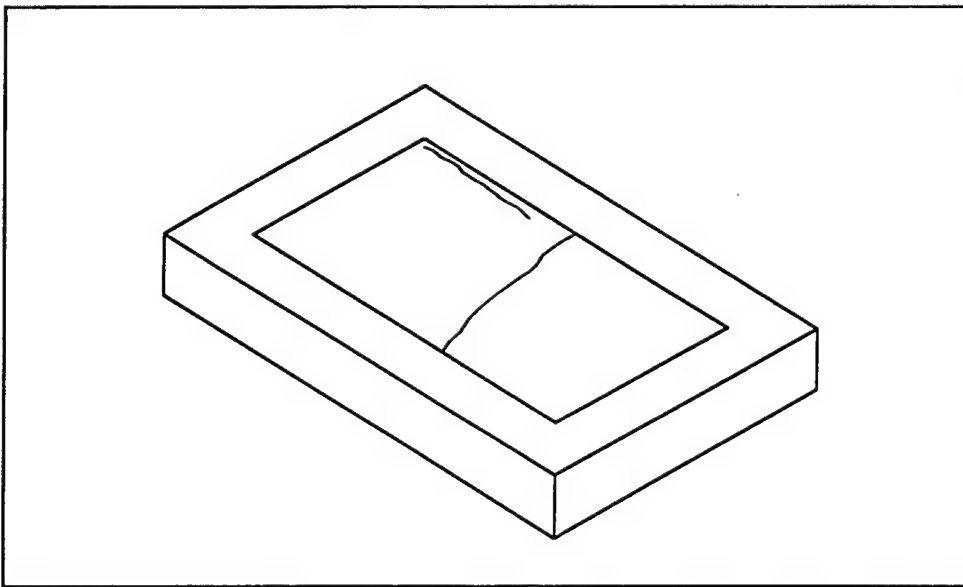
Figure 40. Cracking of Material No. 5B (Arizona)

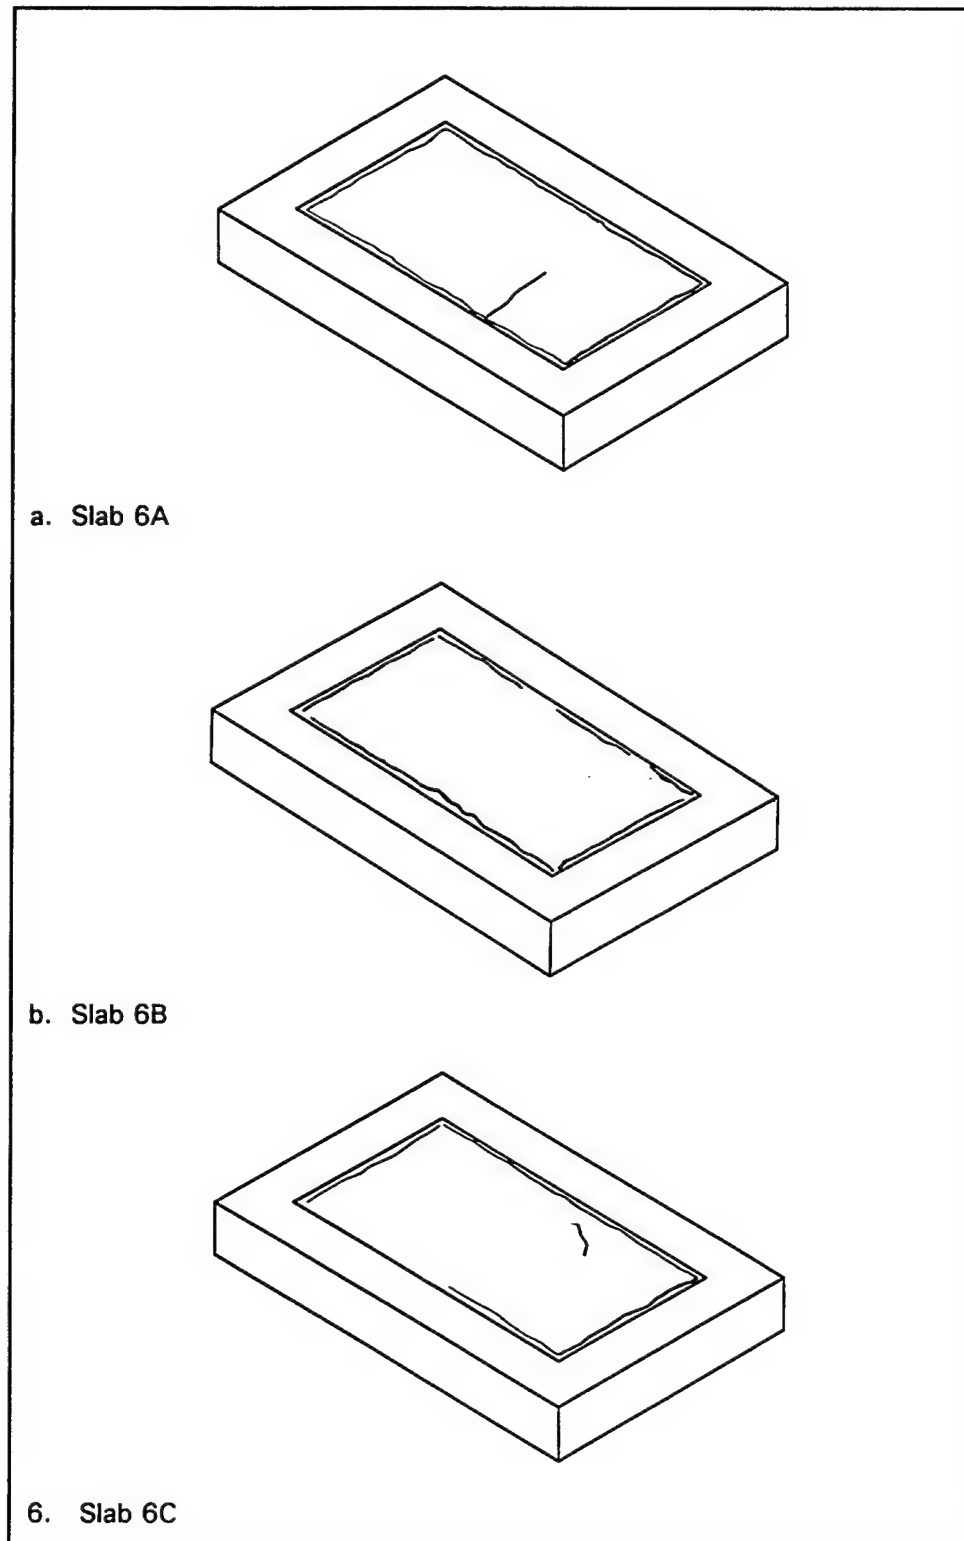
Figure 41. Cracking of Material No. 6 (Arizona)

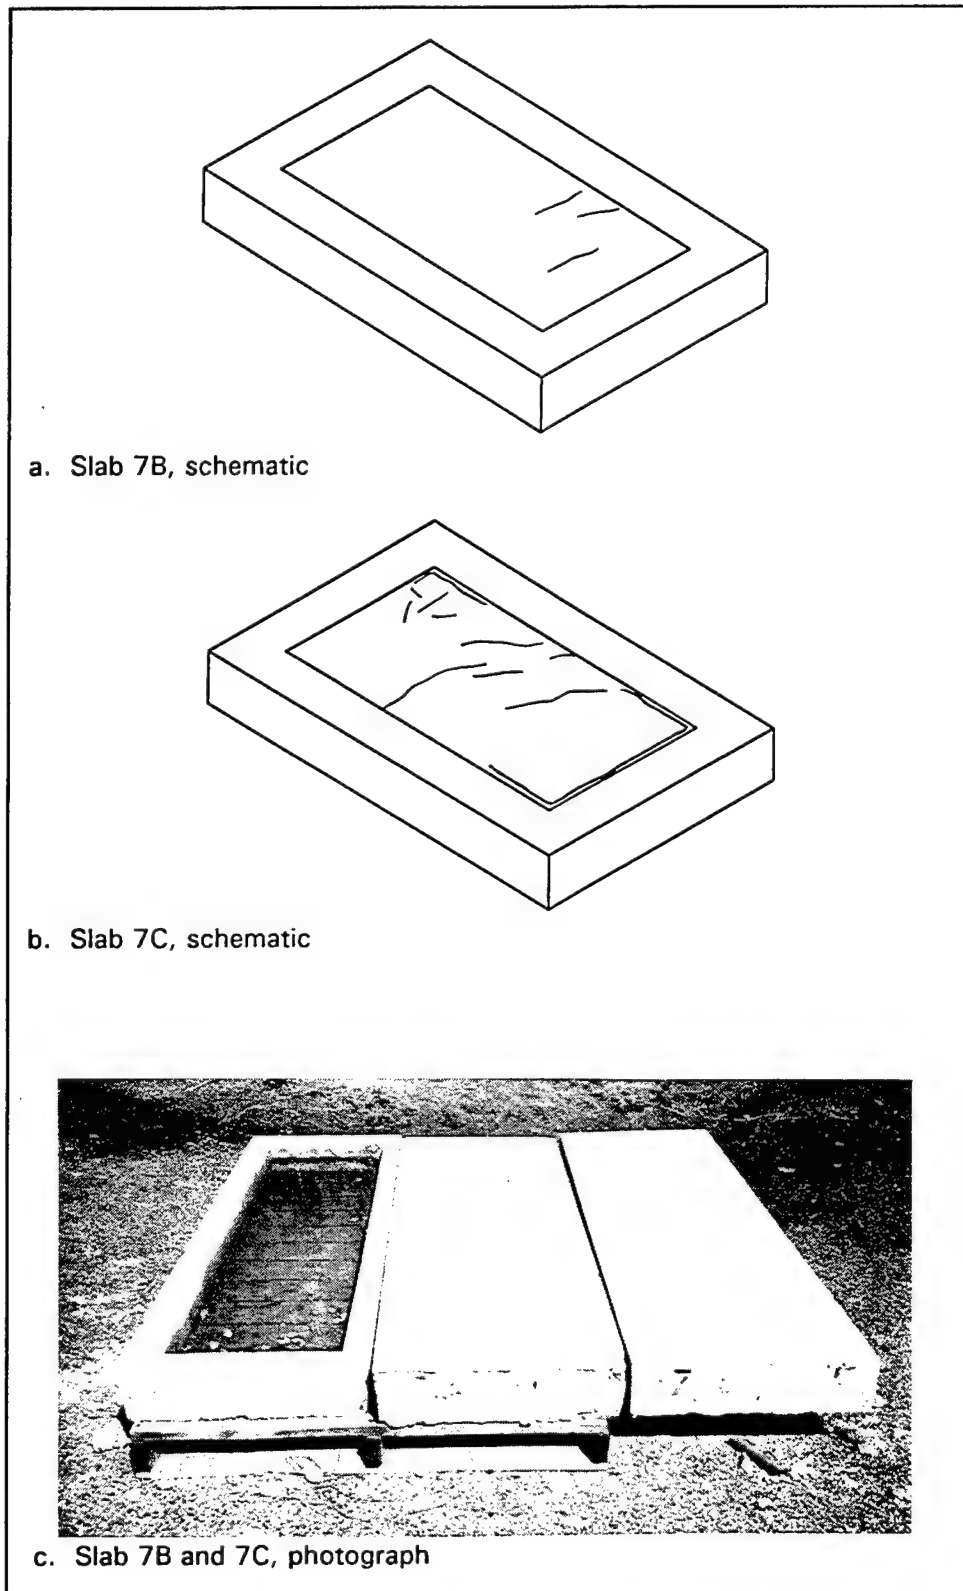
Figure 42. Cracking of Material No. 7 (Arizona)

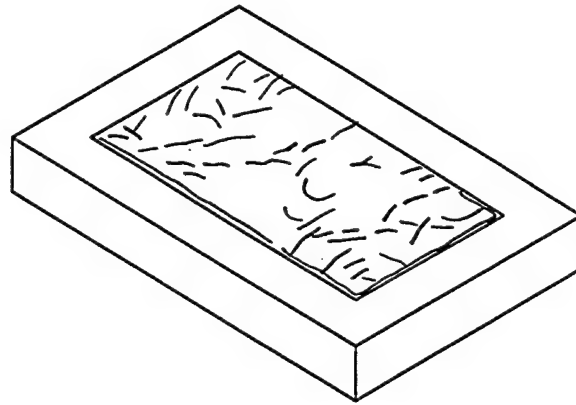
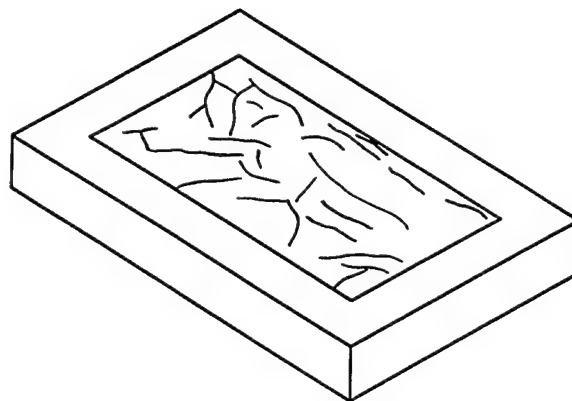
Figure 43. Cracking of Material No. 10 (Arizona)

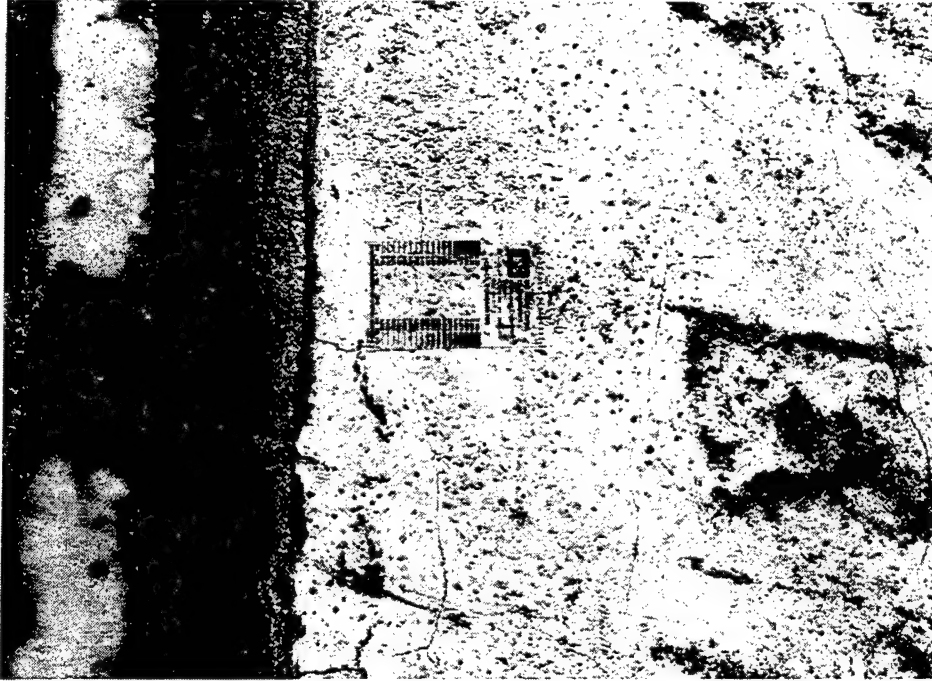
Figure 44. Cracking of Material No. 10C (Arizona)

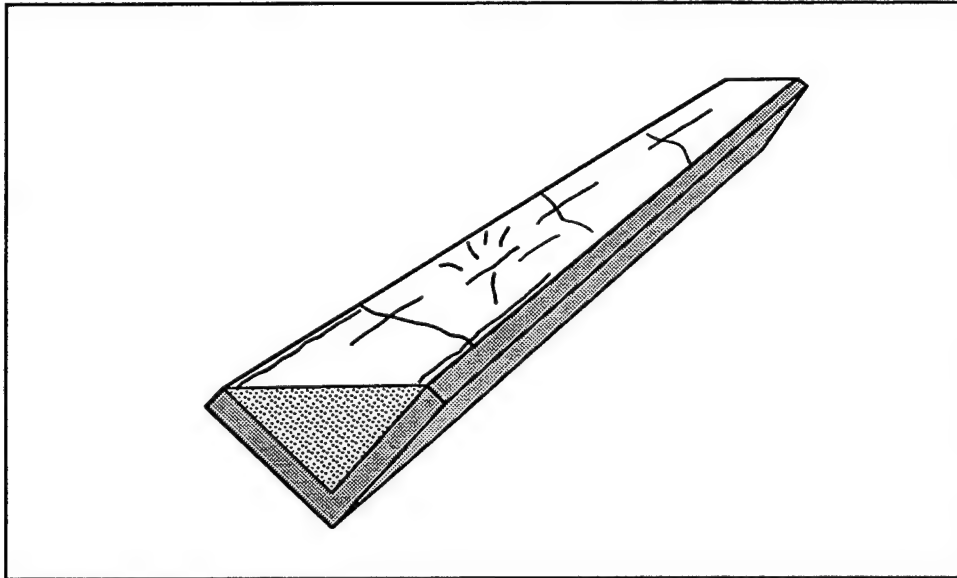
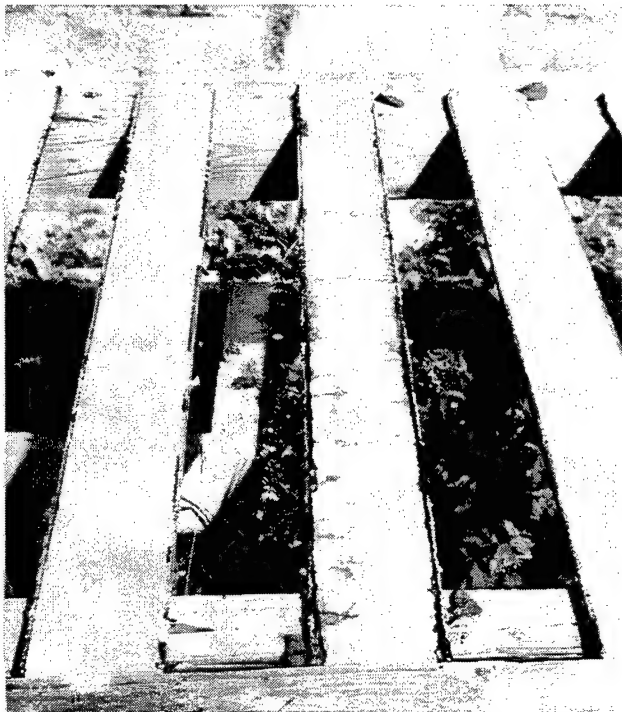
Figure 46. Cracking of Material No. 5 (Florida)

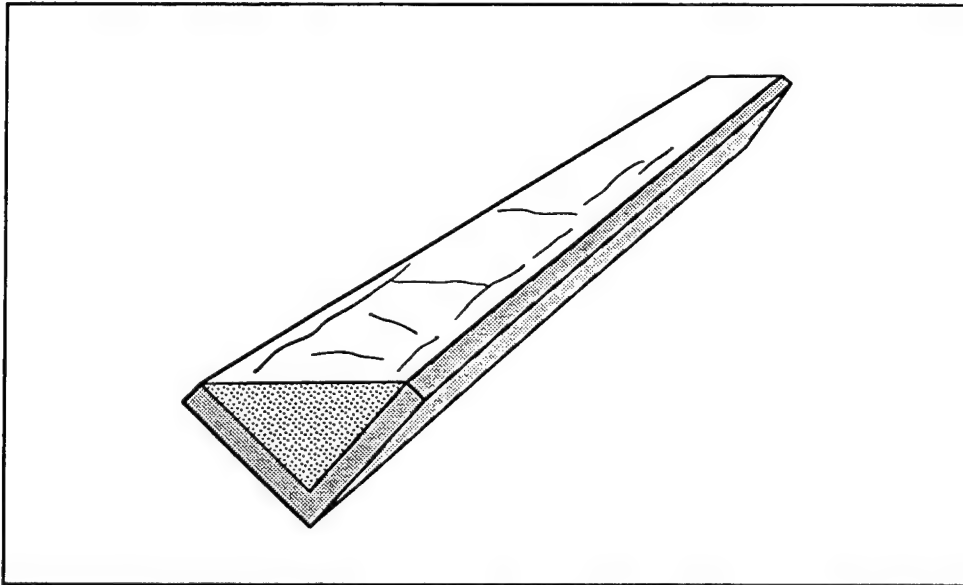
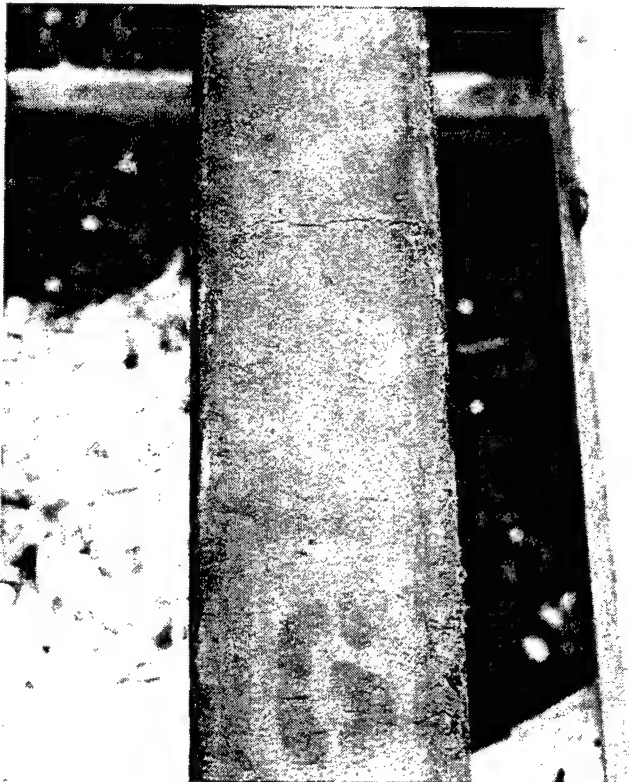
Figure 47. Cracking of Material No. 6 (Florida)

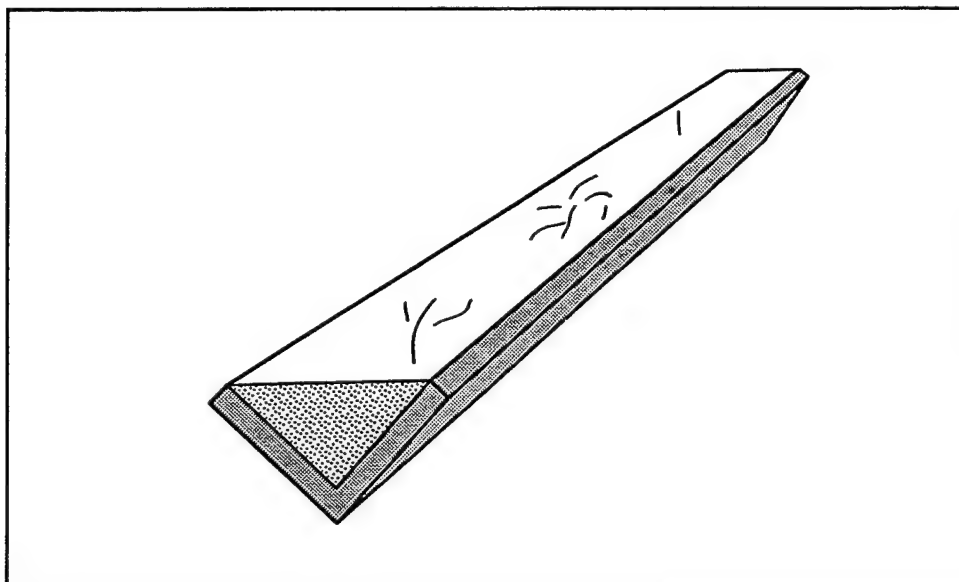
Figure 48. Cracking of Material No. 7 (Florida)

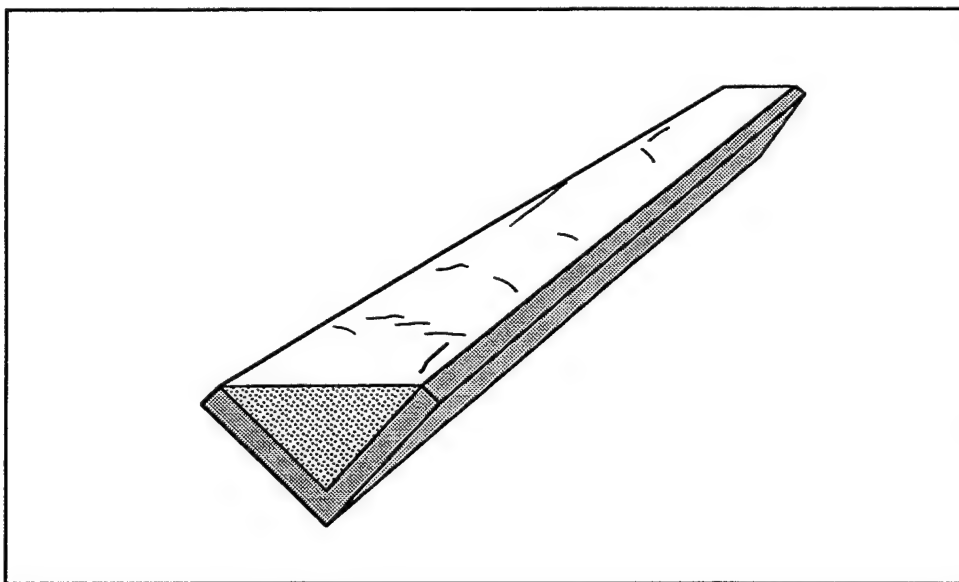
Figure 49. Cracking of Material No. 11 (Florida)

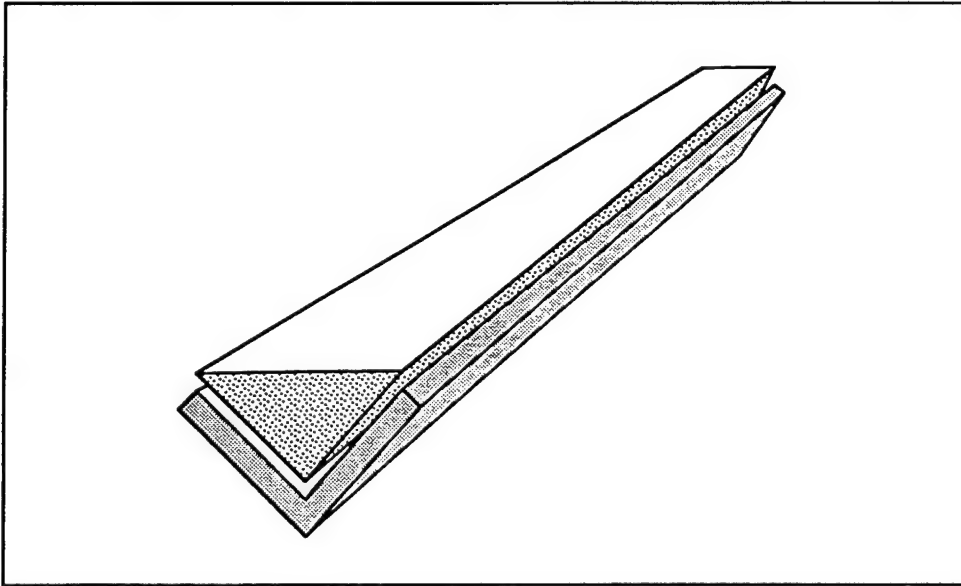
Figure 50. Debonding of Material No. 5 (Illinois)

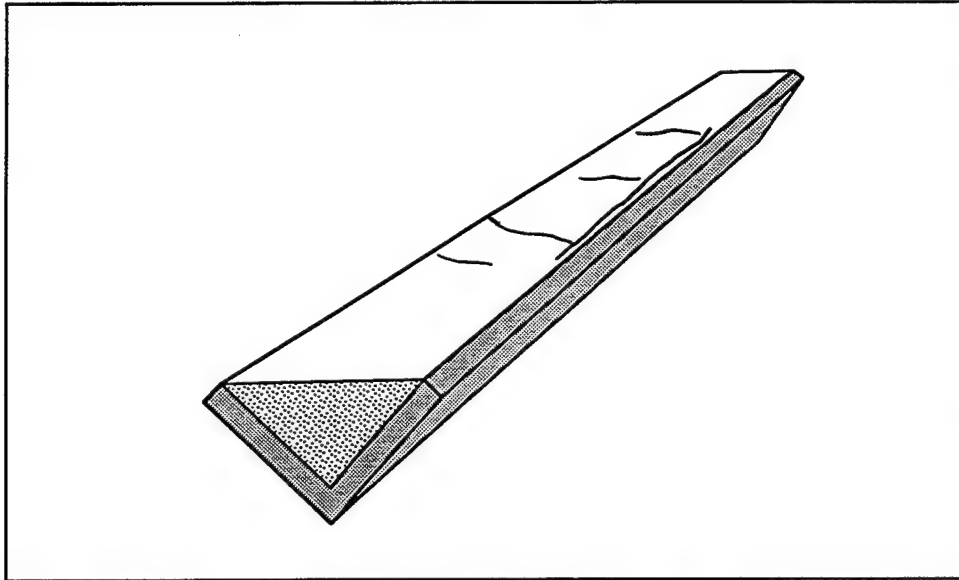
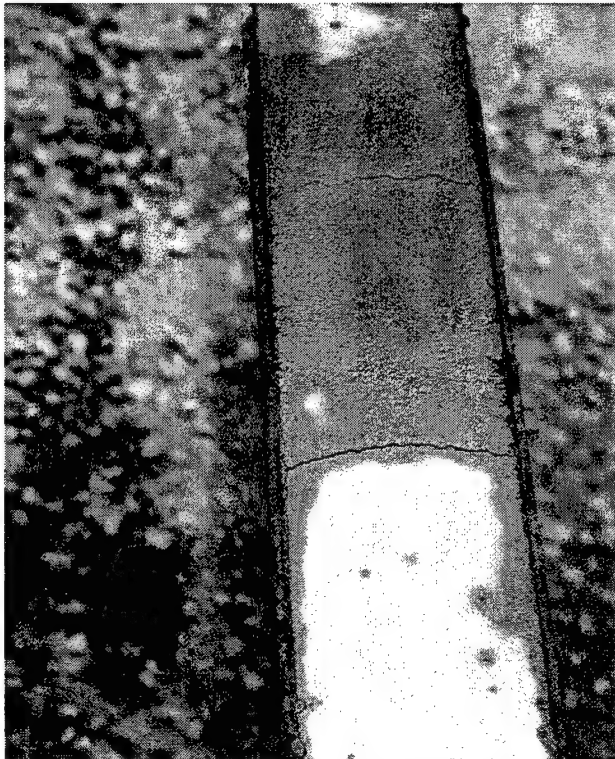
Figure 51. Cracking of Material No. 6 (Illinois)

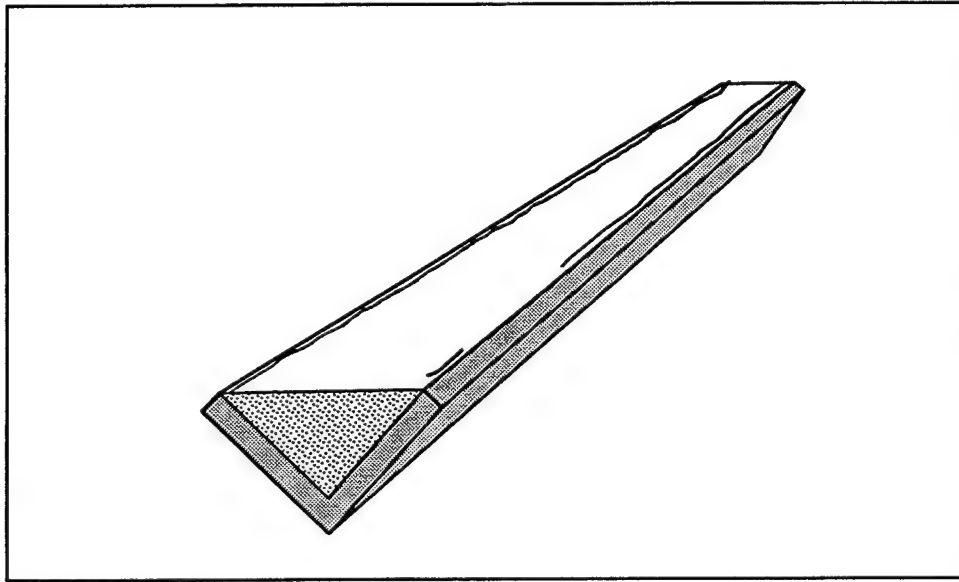
Figure 52. Cracking of Material No. 3 (Arizona)

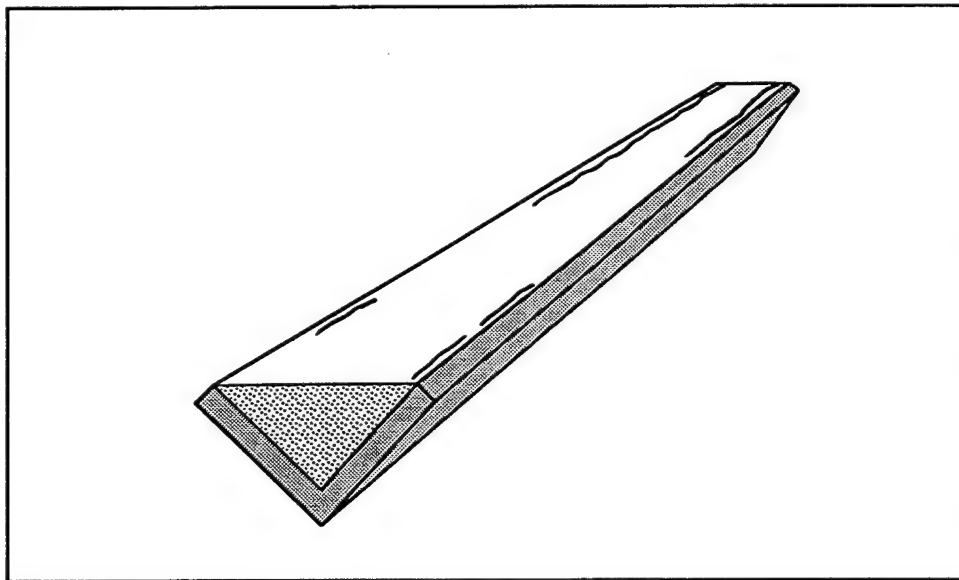
Figure 53. Cracking of Material No. 6 (Arizona)

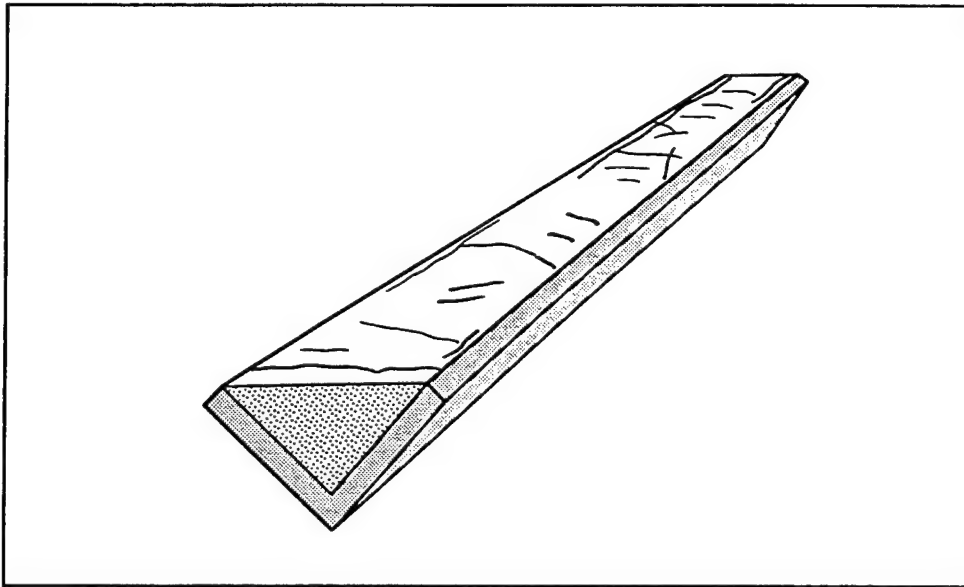
Figure 54. Cracking of Material No. 7 (Arizona)

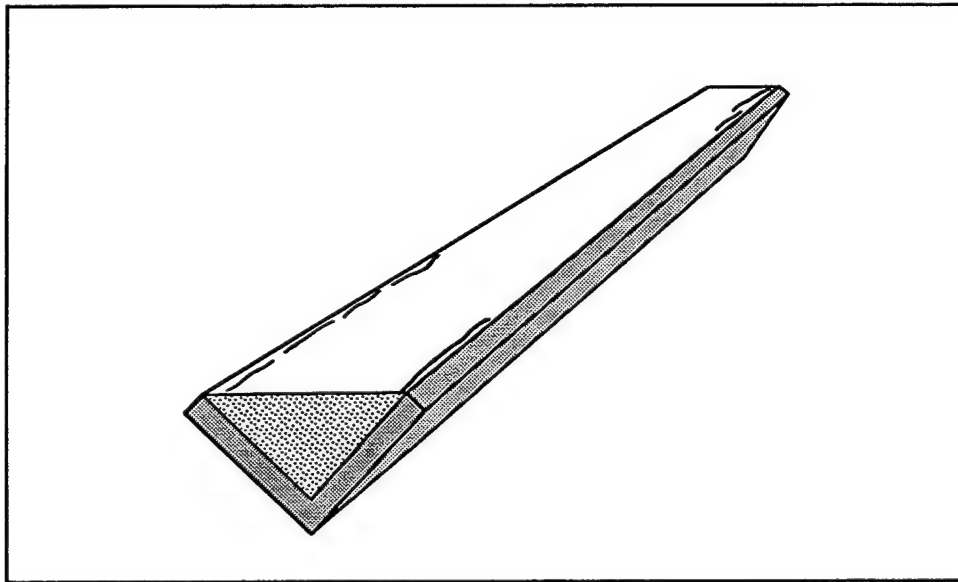
Figure 55. Cracking of Material No. 8 (Arizona)
